**United States Environmental Protection Agency, Region III  
Corrective Action Program**

**FINAL ADMINISTRATIVE RECORD**

**Former Rehrig International  
901 North Lombardy Street  
EPA ID NO. VAD 089 028 377  
Richmond, VA 23220**

**March 18, 2009**

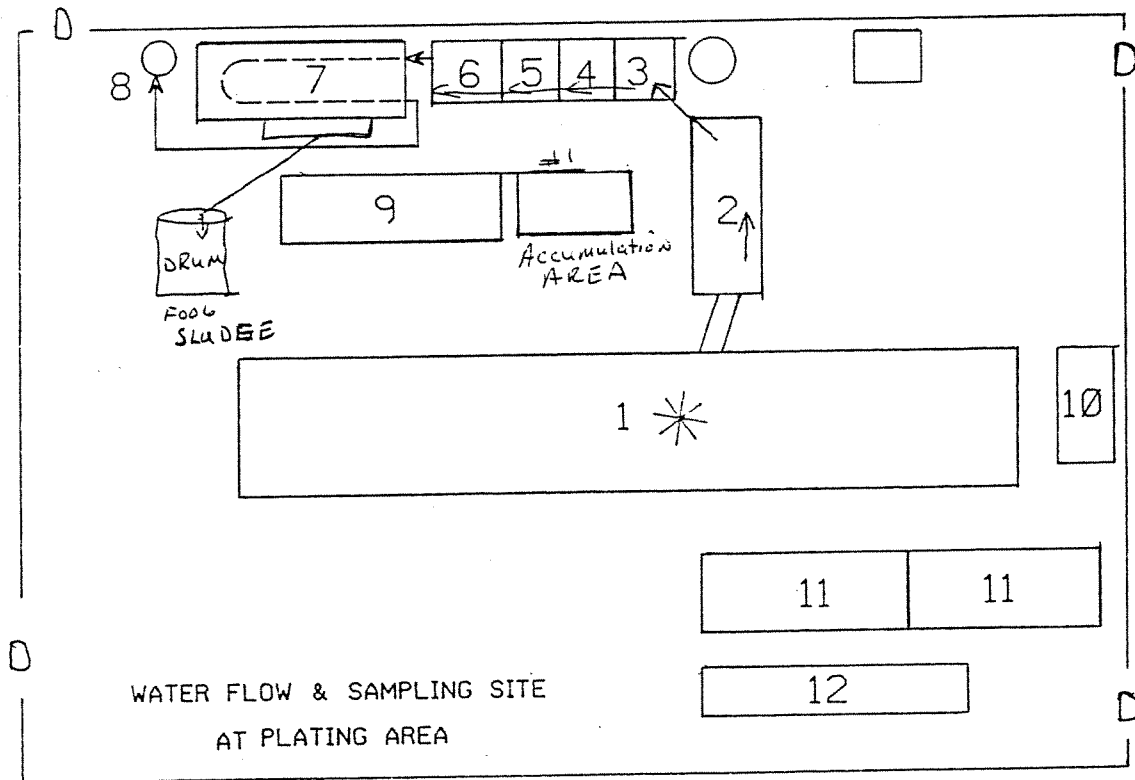
1. NICKLE-TRICHROME plating process
  2. Receiving tank for all water from No.1
  3. thru 7. Wastewater treatment process
  8. Discharge site to city & sampling site for city & lab
  9. Trichrome emergency tank
  10. Acid emergency tank
  11. Nickle emergency tank
  12. Cleaner emergency tank
- \* No.1 has retaining dike for emergency spillage or leaks  
D Doorways

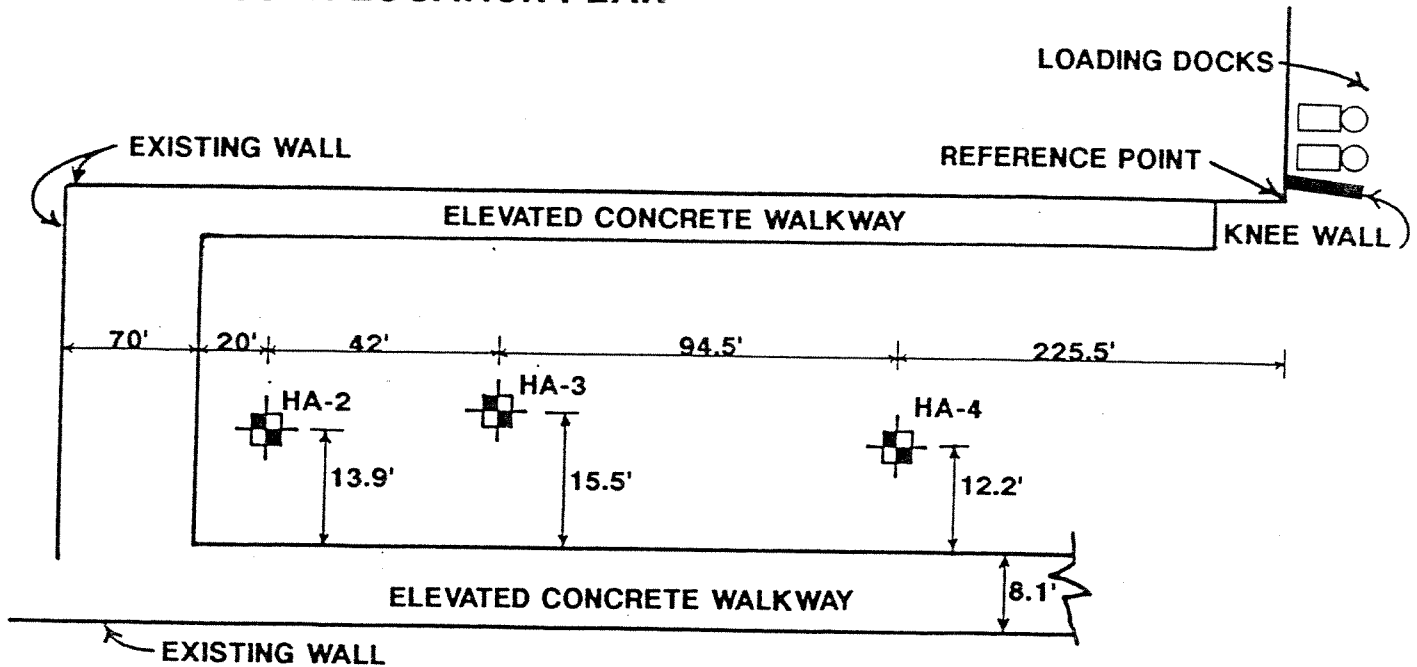
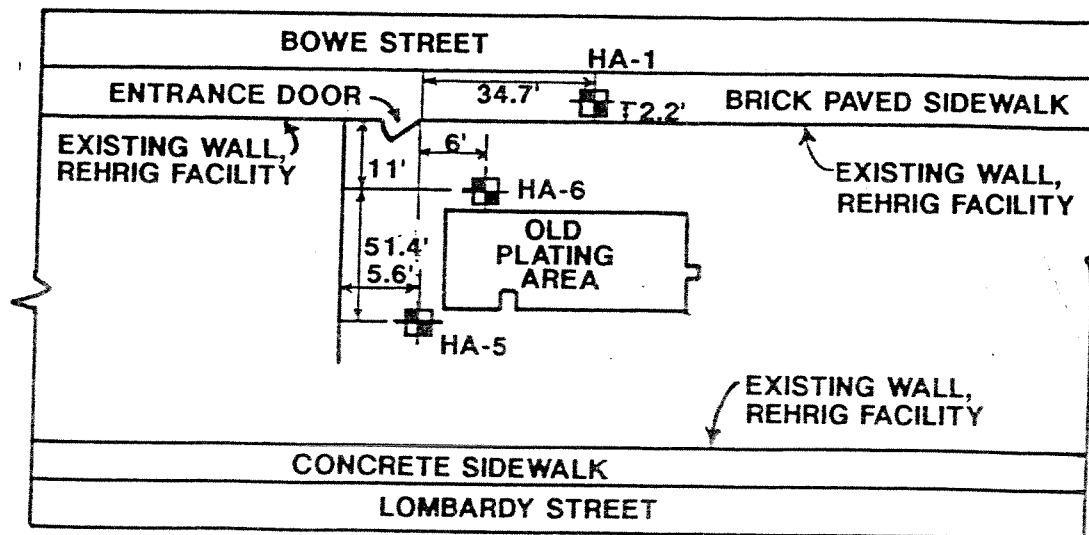
FIGURE 4  
HAND AUGER LOCATION PLAN

NEW PLATING AREA  
NOT TO SCALE

OLD PLATING AREA  
NOT TO SCALE

LOADING DOCK AREA  
NOT TO SCALE

Several borings (hand auger and test borings) were advanced in 1993 as part of an Environmental Site Assessment investigation. The following table summarizes the site-specific geology observed.

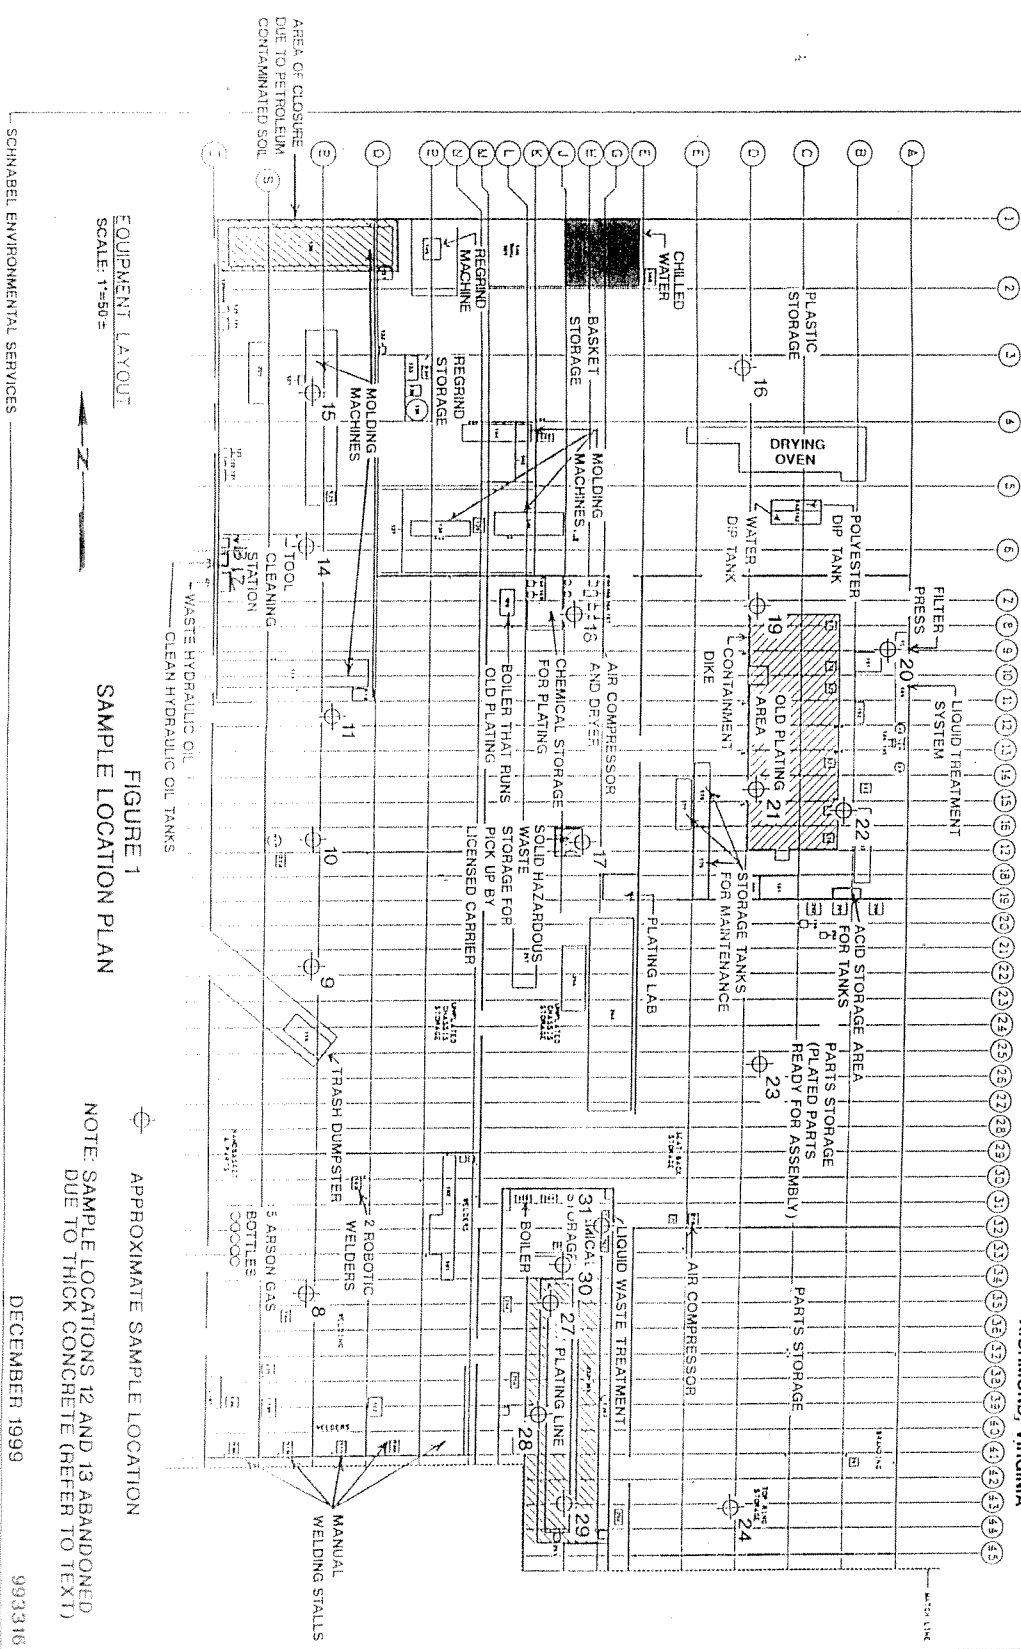
FIGURE 1  
 SAMPLE LOCATION PLAN

EQUIPMENT LAYOUT  
 SCALE: 1"=50'
